Cyanide Chips

TECHNICAL ASSISTANCE TEAM FOR EMERGENCY RESPONSE REMOVAL AND PREVENTION
EPA CONTRACT 68-01-6669

20 October 1983
TAT-5-8310-05

On 14 and 17 October 1983, officers from the Illinois Department of Law Enforcement, Division of State Police, and TAT member Stofferahn conducted inspections of six sites in the Chicago area being used to store cyanide contaminated film chips. These visits were made to assess the structural integrity of the semi-trailer vans which are holding the waste.

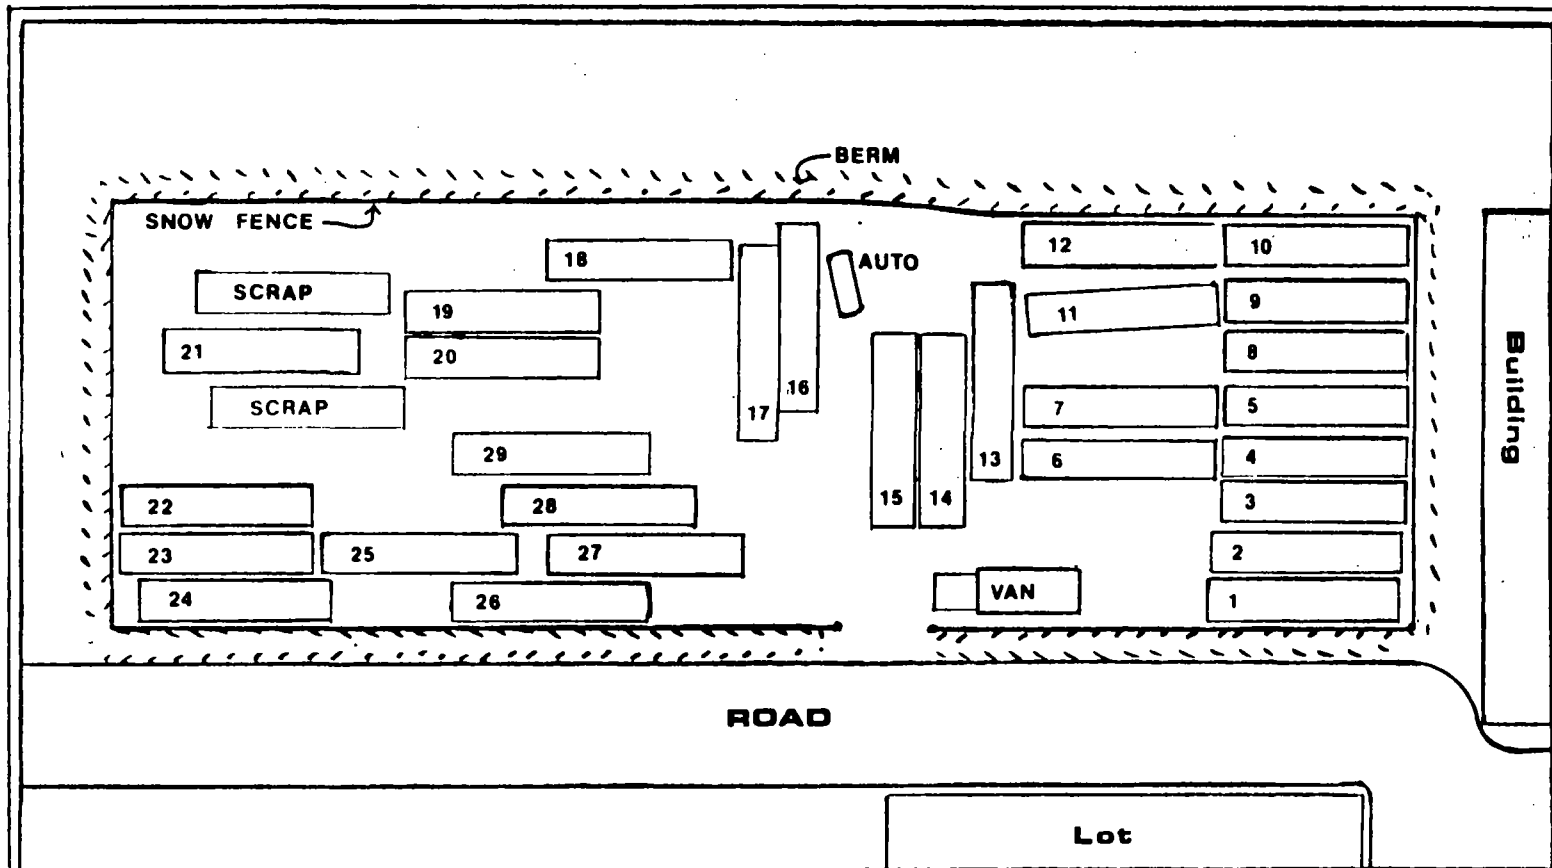
Figure 1

On 14 October 1983, TAT member Stofferahn met with Troopers Koch and Delacy at District Three Headquarters of the Illinois State Police, 4051 N. Harlem Avenue, Chicago. After a brief explanation as to what the site assessments were to involve, the troopers and TAT proceeded to the Red Devil Manufacturing facility at 5995 North River Road, Rosemont, Illinois (Figure 1). Twenty-nine trailers were numbered with spray paint and categorized. The results of the assessment are given in Table 1. Trailer three was found to contain no waste chips. All other trailers were noted to be leaking or seeping leachate to some extent. Five trailers, numbers 13, 15, 18, 27 and 28, were recommended by the officers to be offloaded. The trailers are confined to a small bermed area, and little room to access the majority of the trailers exists. A small asphalt lot was noted across the street from the site which could potentially be used to temporarily store the structurally sound units while the others are being repaired or off-loaded. No information as to the owner of this lot was available at this time.

<u>Trailer #</u>	<u>Category</u>	<u>Comments</u>
1	B	Clear side door and seal
2	C	Patch front seam
3		No waste found inside
4	B	Locked
5	B	Clear rear door
6	C	Front seams corrosion
7	C	Repair back door
8	C	Clear doors and seal
9	C	Seam corrosion
10	B	Locked
11	C	Repair rear door
12	C	Repair rear door
13	D	Waste leakage through floor hole
14	C	Front seam corrosion
15	D	Front and sides leaking chips
16	C	Repair back door, side seams corrosion
17	B	Clear door of chips
18	D	Sides of leaking chips
19	C	Replace back door
20	C	Reinforce floor, front seam corrosion
21	B	Corroded seams
22	C	Seam corrosion, reinforce door
23	B	Clear door seams of chips
24	B	Clear door seams of chips
25	C	Reinforce floor, front side seam corrosion
26	C	Repair rear door
27	D	Chip leakage at doors
28	D	Chip leakage at doors
29	C	Reinforce floor, clear doors

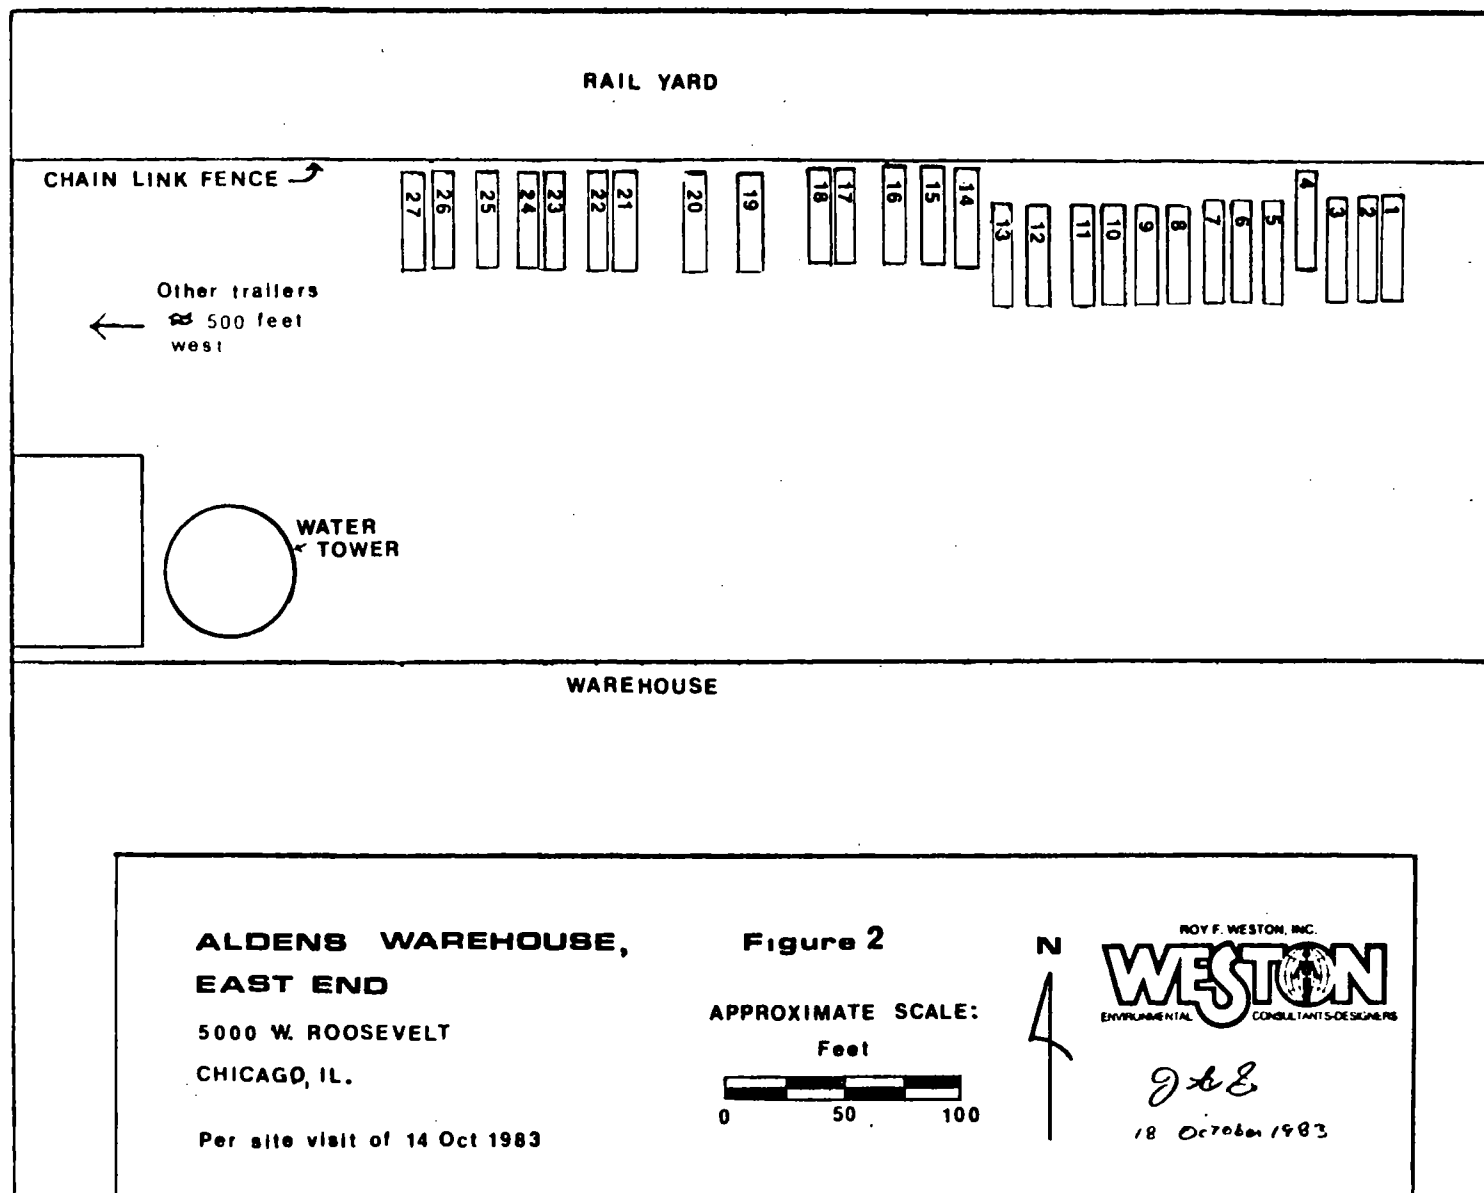
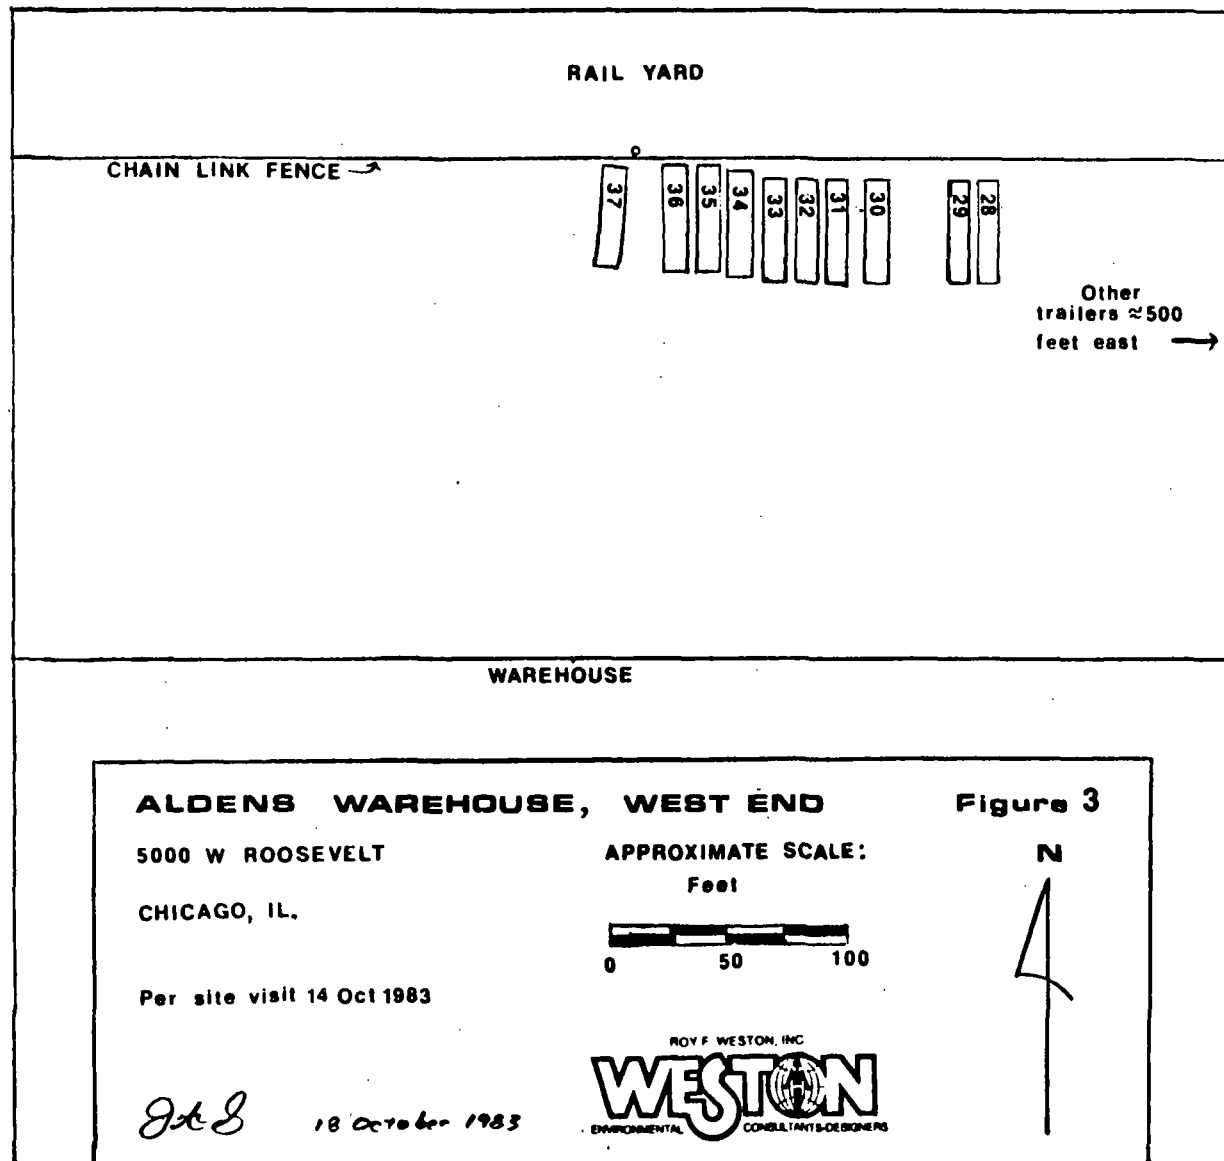
From the Rosemont site, the troopers and TAT proceeded to the abandoned Aldens warehouse site at 5000 W. Roosevelt, Chicago (Figures 2 and 3). Thirty-seven trailers containing chips were numbered with indelible markers. Twenty-seven of these trailers contain chips which were treated with sodium hypochlorite solution by Petrochem Services, Inc., during a state-funded Emergency Action this last summer. Recent analyses, however, have shown these chips still contain significant levels of cyanide and were included in the assessment. The results of the assessment are given in Table 2. Again, all the trailers showed signs of leakage or seepage of leachate (as the weather as been relatively dry prior to the site visits, most of the trailers at this and the Rosemont site were not actively leaking, but showed definite signs of past leakage). The troopers recommended that ten trailers, numbers 2, 3, 5, 11, 17, 30, 32, 33, 34 and 35, should be off-loaded. The trailers are situated on a

<u>Trailer #</u>	<u>Category</u>	<u>Comments</u>
1	C	Repair floor
2	D	Chips leak at seams, sides bulging
3	D	Front bulging, seams leaking
4	B	Corrosion at door and seams
5	D	Floor and back door unstable, leaking chips
6	C	Repair floor
7	C	Repair floor
8	B	Clear back door
9	C	Front seam corrosion, reinforce back door
10	C	Seam corrosion, seal back door
11	D	Sides bulged, chips leaking at rear
12	C	Seam corrosion, clear rear door
13	B	Clear rear door
14	C	Repair rear door
15	C	Seam corrosion, replace rear door
16	C	Clear rear door, front seam corrosion
17	D	Hole in floor, sides corroded
18	C	Front seam corrosion seal rear
19	C	Seam corrosion
20	C	Seam corrosion
21	C	Seam corrosion
22	C	Seam corrosion
23	C	Seam corrosion
24	C	Seam corrosion
25	C	Seam corrosion
26	C	Seam corrosion
27	C	Seam corrosion
28	C	Seam corrosion
29	C	Seam corrosion
30	D	Sides bulging
31	C	Seam corrosion
32	D	Unstable sides and rear
33	D	Leakage of chips through side corrosion

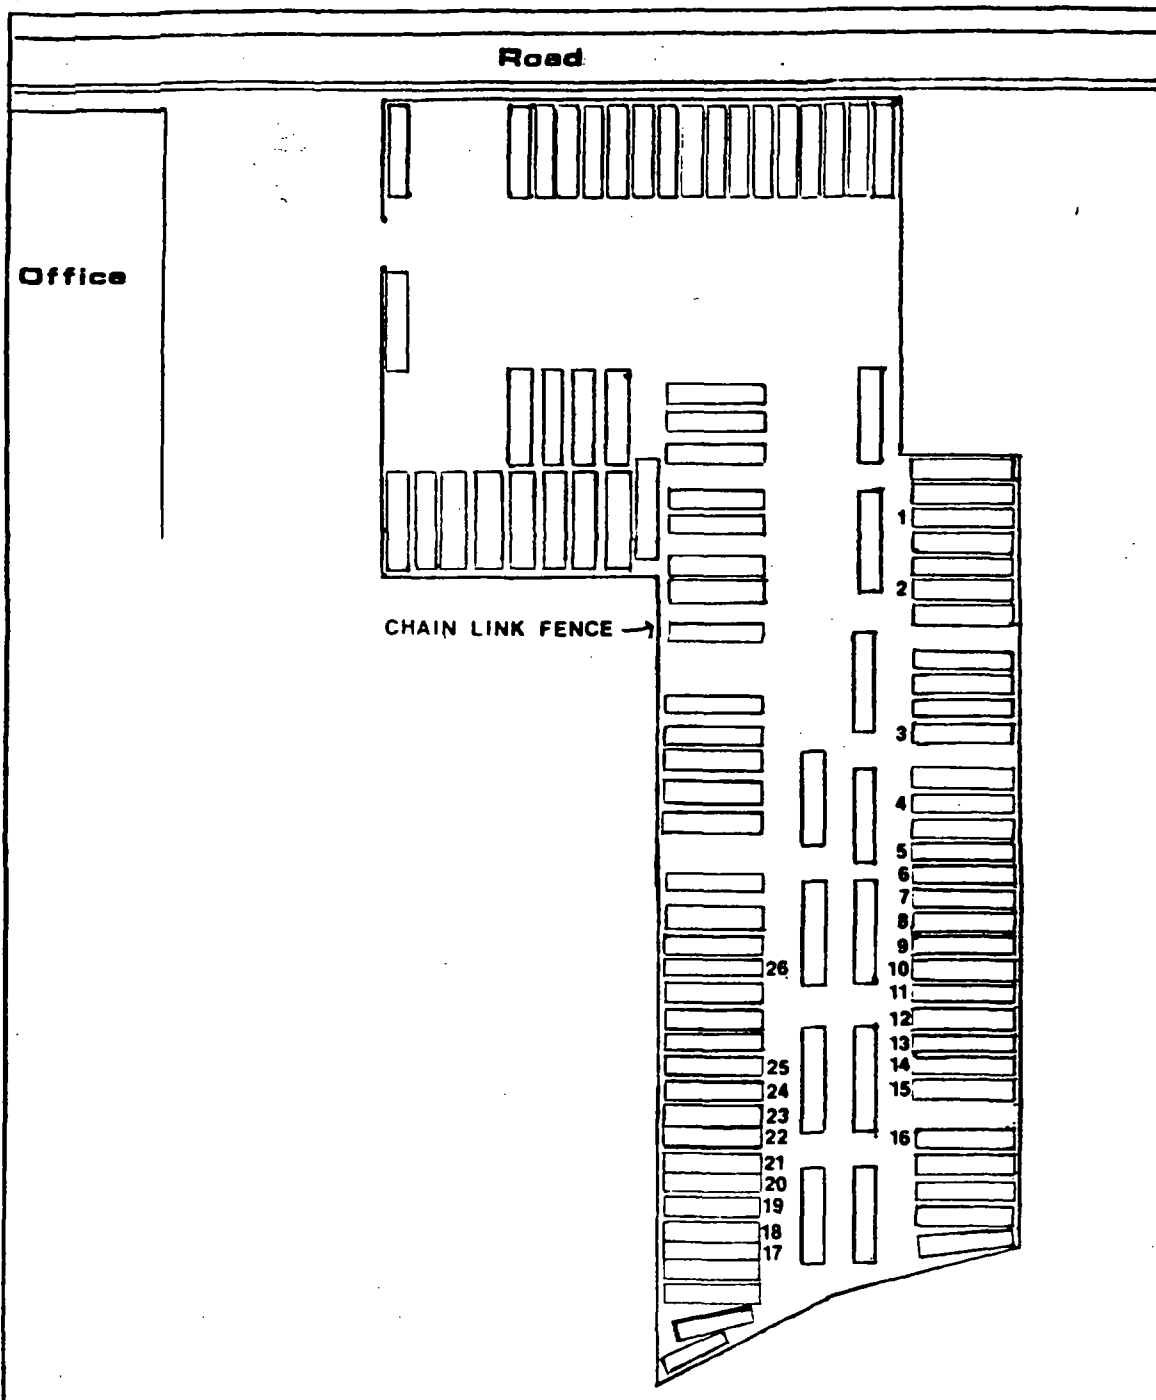
GEMINI LEASING (RITE-WAY) Figure 4

On 17 October 1983, TAT member Stofferahn met with Sargent Underwood and Troopers Zipsie and Patterson from District Four State Police Headquarters (13863 S. Cicero, Crestwood, Illinois) at the Gemini Leasing yard, 6021 S. East Avenue, Hodgkins, Illinois (Figure 4). The Gemini Leasing yard is an active facility. Twenty-six trailers containing waste chips located here were numbered with indelible markers. The results of the assessment of these trailers are given in Table 3. Most of the trailers were leaking; some were without jack stands. Nine trailers, numbers 11, 12, 14, 17, 19, 22, 23, 25 and 26, were recommended for offloading by the troopers. While gaining access to the twenty-six trailers will require only a minimal amount of movement of other units on the yard, acquiring room for repairs and offloading will be a problem due to the fact that this is an active place of business. The owner of the yard, who TAT met briefly during the site visit, complained that the waste trailers were taking up space on his yard which he could be utilizing for paying customers. The addition of ten more trailers, or several roll-off boxes, to store the chips from the ten unsound units is not anticipated to elicit a favorable response from Gemini officials.

<u>Trailer #</u>	<u>Category</u>	<u>Comments</u>
1	B	Leaking at front
2	B	Leaking at front
3	B	Leaking at front
4	C	Repair side door, sides bowed
5	C	Side door sprung, leaking
6	B	Leaking - floor rotting
7	A	
8	C	Floor rotting, sides sprung from frame
9	C	Side walls sprung, seam corrosion
10	C	Seam corrosion
11	D	Holes in side, floor rotting
12	D	Holes in side, floor near collapse
13	C	Side seam corrosion, floor leakage
14	D	Side corrosion, floor leakage
15	C	Side walls sprung, leaking
16	C	Side corrosion, leaking
17	D	Side corrosion, leaking
18	C	Front seam corrosion, leaking
19	D	Side corrosion, leaking
20	B	
21	C	Minimal side corrosion, leaking
22	D	Top damaged, side walls sprung, leaking
23	D	Side walls sprung, front and side seam corrosion
24	C	Front seam corrosion, leaking
25	D	Floor buckled, sides bowed, leaking
26	D	Side corrosion, leaking

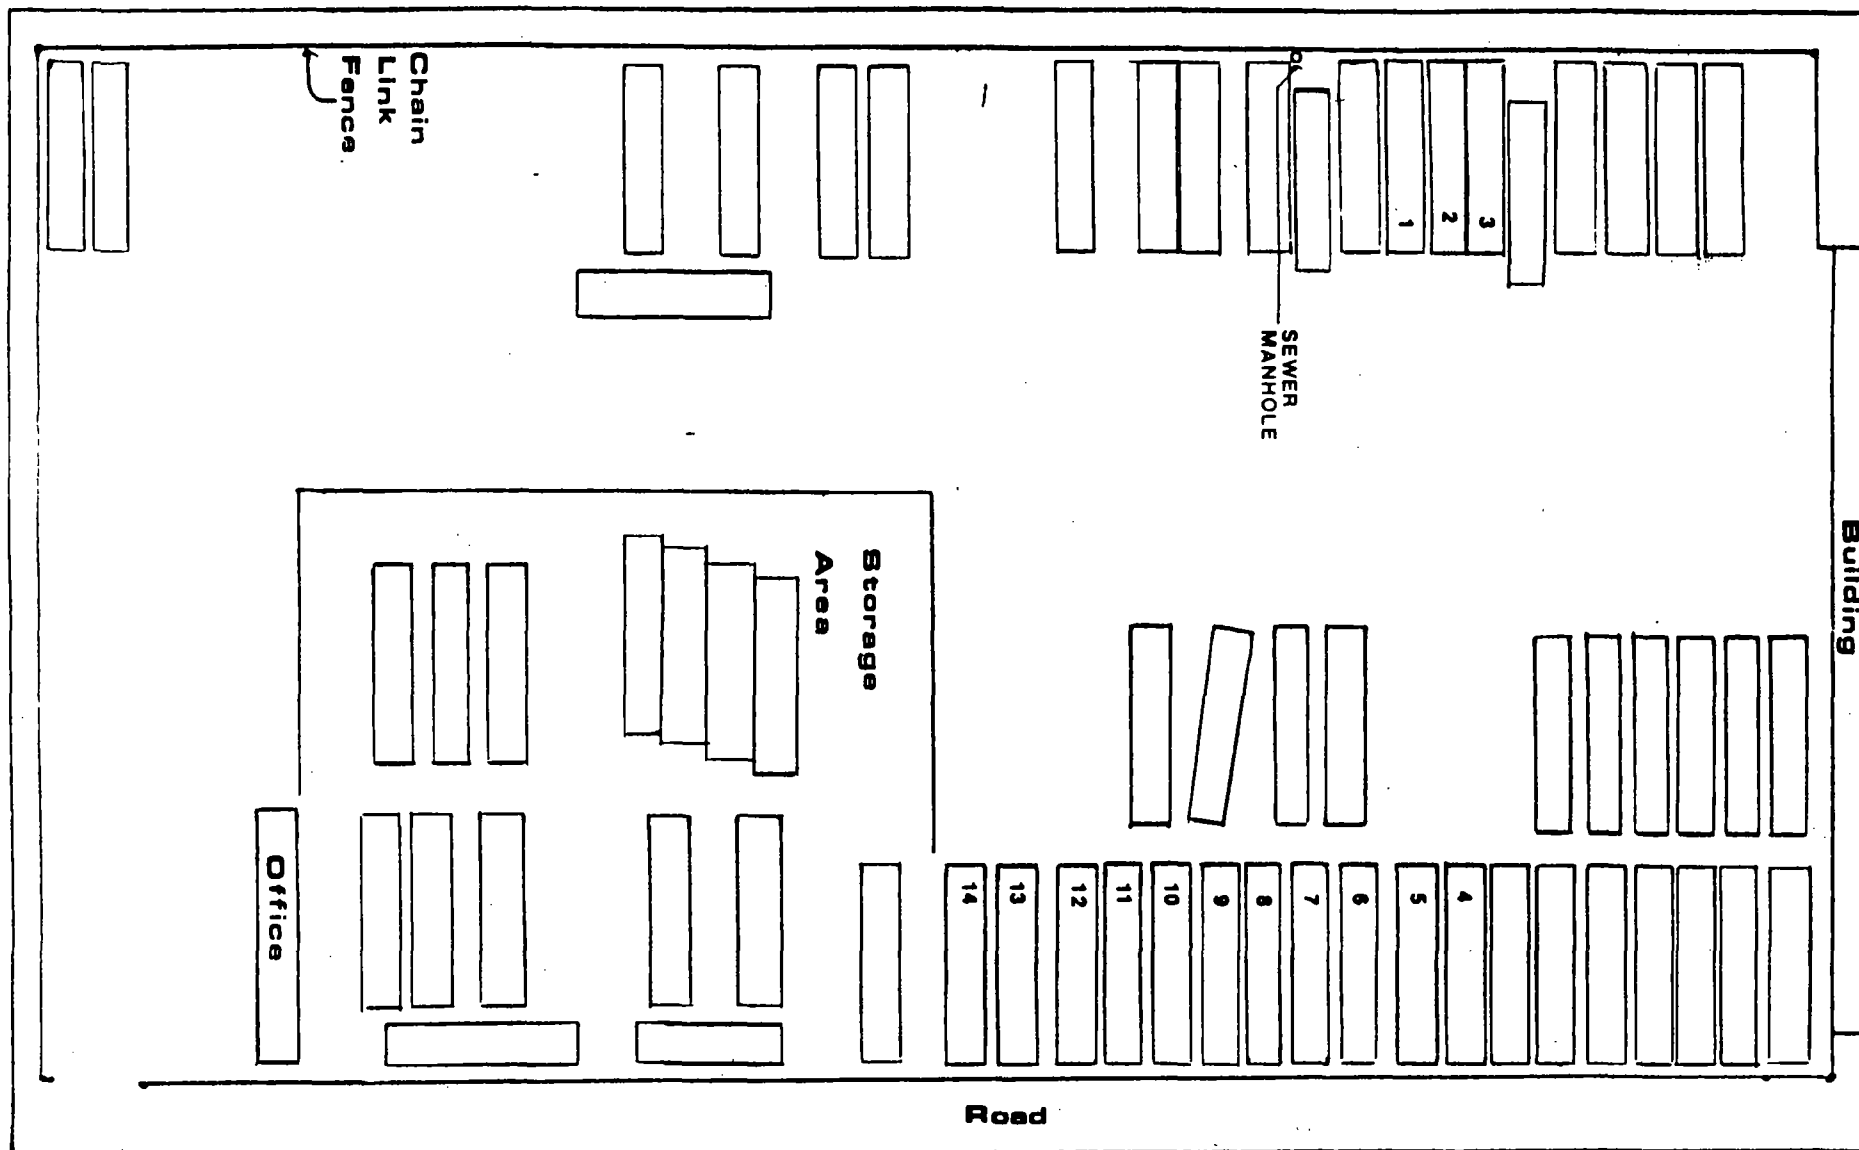
Figure 5

The next site assessed was J's Mobile Semi-Trailer Repair yard at 8765 W. Joliet Road, McCook, Illinois (Figure 5). Fourteen trailers located here were numbered and assessed. The results of the assessment are given in Table 4. Leakage of leachate from these trailers had been found to be migrating off site via a storm sewer by personnel from the Metropolitan Sanitary District of Greater Chicago (MSD) in September of 1983. Four trailers, numbers 1, 3, 6 and 7, were recommended to be offloaded. As with the Gemini Leasing yard, this is an active trailer yard. Access to the waste trailers is not anticipated to be a serious problem; however, finding enough room for repairs and offloading is.

<u>Trailer #</u>	<u>Category</u>	<u>Comments</u>
1	D	Rear door missing, side and front corrosion
2	C	Possible frame damage, side corrosion
3	D	Floor in very bad condition
4	B	Floor leakage
5	C	Rear seam corrosion
6	D	Much floor rotting
7	D	Floor buckled, considerable seam corrosion
8	C	Right side corrosion, clear rear door
9	C	Front and left side corrosion
10	C	Cross member in floor bowed and twisted, side corrosion
11	B	Leaking at rear door
12	C	Side corrosion
13	C	Side corrosion
14	A

the tops of the trailer walls, (with the plastic sandwich between the wall and wood to secure the sheet). As the migration of contaminants off-site have been documented at both the McCook and Summit sites, the two facilities should be dealt with initially.

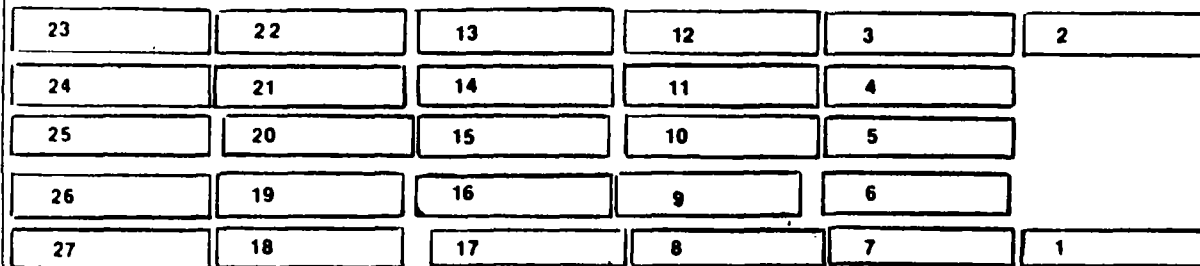
EAGLE TRAILER INC. Figure 6

The Eagles Trailer yard at 7710 W. 57th Street, Summit, Illinois (Figure 6), was the next site visited. Twenty-seven trailers containing waste were numbered and assessed. The results of the assessment are given in Table 5. As with the J's site, off-site migration of cyanide via a drainage ditch along the southern parameter of the site was documented by the MSD last September. Three units, numbers 2, 4 and 16, were recommended for off-loading. A considerable access and congestion problem was noted at this site. There is a totally inadequate amount of space within the area where the trailers are parked for any amount of work to be done. The trailer repair yard to the north is active, and cannot be used. The paved area leading to Archer Avenue could be used for temporary storage of sound units. To the northeast, TAT noticed a very large paved parking lot and what appeared to be abandoned buildings. This lot could also potentially be utilized for temporary storage or working space. An Eagle's employee stated this facility was owned by Ryder P.I.E., and supplied TAT with a business card for a contact with the firm (Attachment 1).

<u>Trailer #</u>	<u>Category</u>	<u>Comments</u>
1	B	
2	D	Side corrosion
3	B	
4	D	Side corrosion
5	B	
6	B	
7	B	
8	C	Side corrosion
9	B	Leaking side door
10	B	Leaking side door
11	B	Leaking floor
12	B	Leaking side door
13	B	Leaking floor
14	B	Leaking sides
15	B	
16	D	Side seam corrosion, side door sprung
17	B	Leaking sides
18	B	Leaking front
19	C	Front upright brace cracked, front seam corrosion
20	B	Leaking side
21	A	
22	B	Leaking floor
23	B	
24	A	
25	A	
26	B	Leaking side
27	B	Leaking floor
